Godiva Service Bulletin 90

Electronic Pneumatic Ball Valve Reconfiguration

Effective Date:	March 2023
Subject:	Change to Mechanical Assembly of Electro-Pneumatic Valve (Part Number 65532)
Unit(S) Effected:	Godiva World Series, Prima and Prima CAFS Manufactured Since 2008

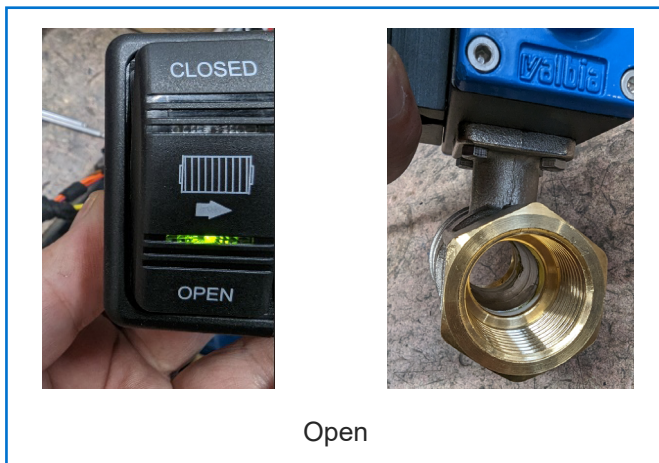
Open

- Remove the hose / plumbing for visible access to the ball valve
- Power the vehicle, ensure the pump has an electrical and pressurised air supply
- Check the Switch Operation
 1. Ball valve open and switch open
 2. Ball valve closed and switch closed

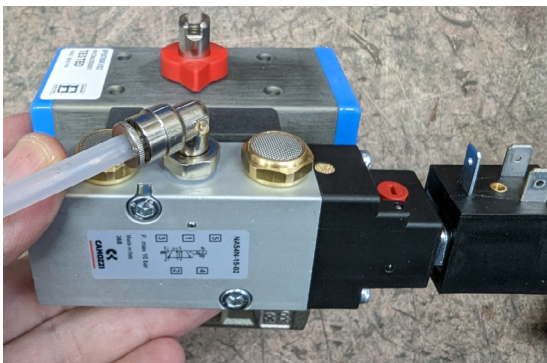
- Retain air pressure but remove electrical supply (disconnect the terminal block)

In most cases the ball valve will be closed in this condition. Not all switch wiring is by Godiva, the check should be carried out to confirm the set up. This confirms the default condition is “dry”, the following instructions allow the valve to be reconfigured to a “wet” default.

As per the bulletin, Godiva will be supplying the set up to default the ball valve open with the electrical supply removed. The follow steps will replicate the latest Godiva build.
